Project Features

Project name:	Medical Waste Incinerators
Project code:	EE-2005-04
Objective:	Design, supervision and construction of medical waste incinerators.
Project focus:	Treating medical waste
Location:	Handeni, Mwanza and Magu, Tanzania
Implementation agency:	EPCO
Funded by:	Ministry of Health, WHO
Project duration:	05/2005 – 05/2006
Project costs:	Unit cost 4,000.00 USD
Project leader(s):	Edmund John

Detailed Project Description

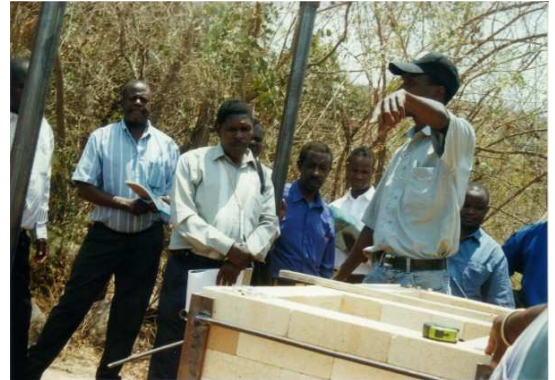
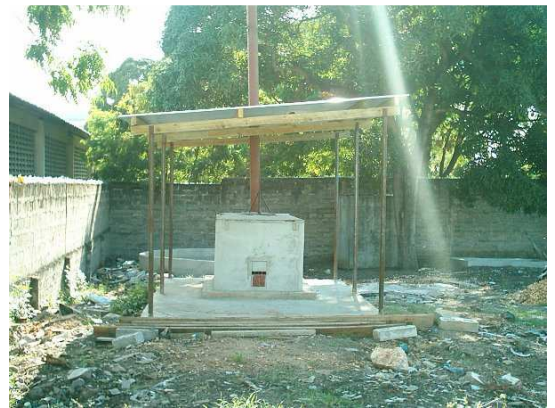
The incinerator is built on site with locally available materials (refractory bricks, refractory mortar, mild steel door, frame, grates and stack and standard building bricks). It has a secondary combustion chamber to reduce harmful emissions. When residual combustible gases reach the secondary combustion chamber they meet a further supply of air and undergo secondary combustion, raising the temperature even higher, and reducing the gases to stable compounds such as carbon dioxide. The incinerator is loaded at start-up and may then be re-loaded from time to time while in operation.

The incinerator operates with natural draught, requires fuel to start and takes time to reach operating temperature from cold. It is therefore best operated for long periods, not less than four hours at a time. It is not suitable for operation in a closed room. Smoke will be emitted whenever the loading door is opened. A roof may be fitted to protect the operator from rain, but only minimum walls. The walls of the incinerator never become dangerously hot to touch, even during operation, because of the double walls and sand infill between the walls.
